Manhole Inspection Summary

Manhole # S63G__025MH

Location Address: **5100 Bayview Blvd.**

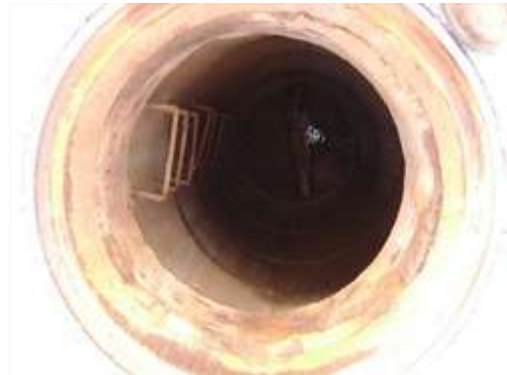
Top View

Condition: **Cracked**

Condition: ☐ Sound ☐ Cracked ☐ Root Intrusion ☒ **Loose Brick** ☒ **Deteriorated**

Infiltration: ☐ None ☒ **Joint** ☐ Cracks ☒ **Mortar** ☐ Roots ☐ Wall
